ASBESTOS RE-INSPECTION SURVEY REPORT

WAREHOUSE 5
GSA BUILDING NUMBER WA0821KF
2201 C STREET SW
AUBURN, WASHINGTON

ASSESSMENT DATE:
09-13- 2012

PREPARED BY:
UNITED STATES PUBLIC HEALTH SERVICE
FEDERAL OCCUPATIONAL HEALTH SERVICE
DALLAS AREA OFFICE
1301 YOUNG STREET, SUITE 772
DALLAS, TX 75202

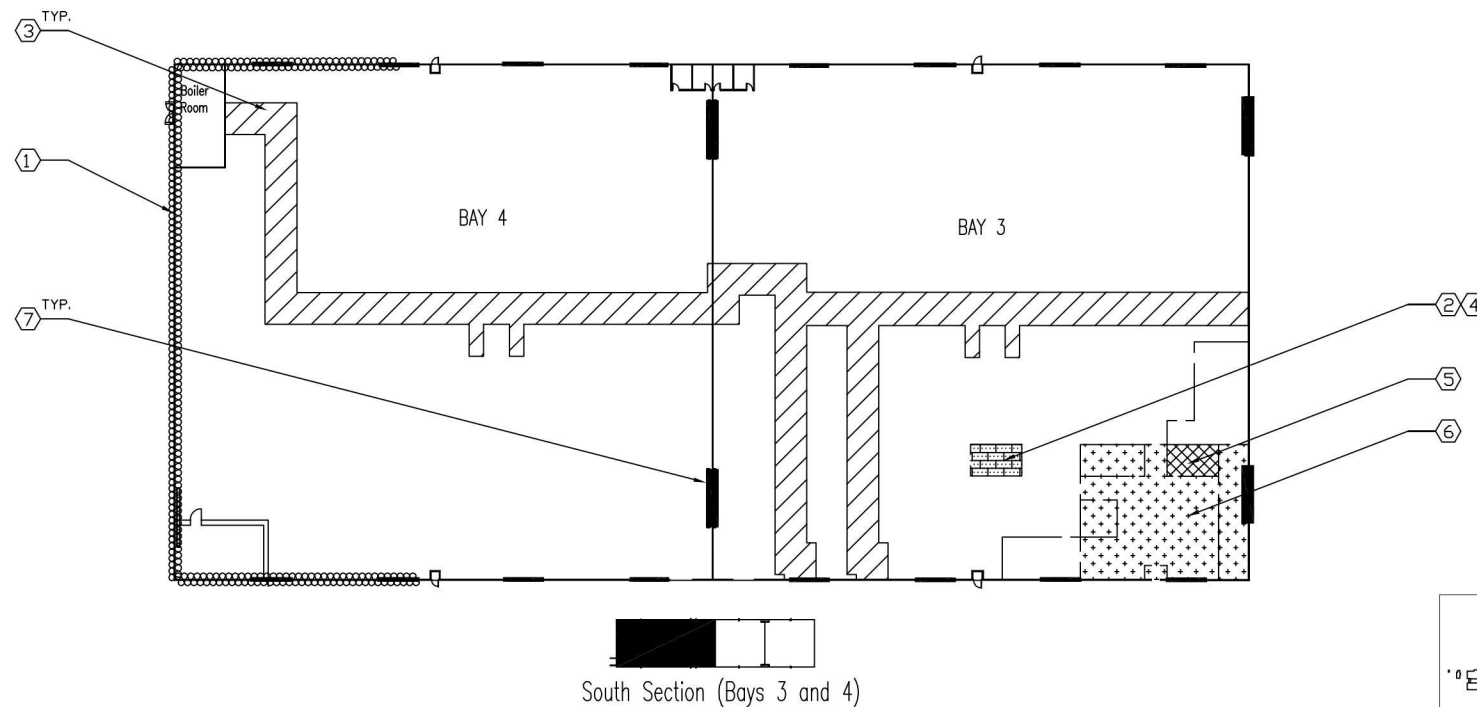
South Section (Bays 3 and 4)

- ① CEMENT ASBESTOS BOARD EXTERIOR SIDING AND ASSUMED ASBESTOS CONTAINING FELT VAPOR BARRIER PAPER
- ② 9" VINYL ASBESTOS TILE AND ASBESTOS CONTAINING MASTIC ON WOOD
- ③ ASBESTOS CONTAINING TSI ON PIPING (INCLUDES FITTINGS)
- ④ NON-ASBESTOS CONTAINING 1' X 1' ACOUSTIC CEILING TILE WITH ASBESTOS CONTAINING MASTIC
- ⑤ 9" GREEN VINYL ASBESTOS TILE AND NON-ASBESTOS CONTAINING MASTIC UNDER NON-ASBESTOS CONTAINING 12" VINYL FLOOR TILE AND NON-ASBESTOS CONTAINING MASTIC, ON CONCRETE
- ⑥ 9" GREEN VINYL ASBESTOS TILE AND NON-ASBESTOS CONTAINING MASTIC ON CONCRETE, UNDER CARPET SQUARES
- ⑦ ASBESTOS CONTAINING CORE FIRE DOORS. INTERNAL FIRE DOORS SEPARATE BAYS AND ARE APPROXIMATELY 10' X 20' EACH.

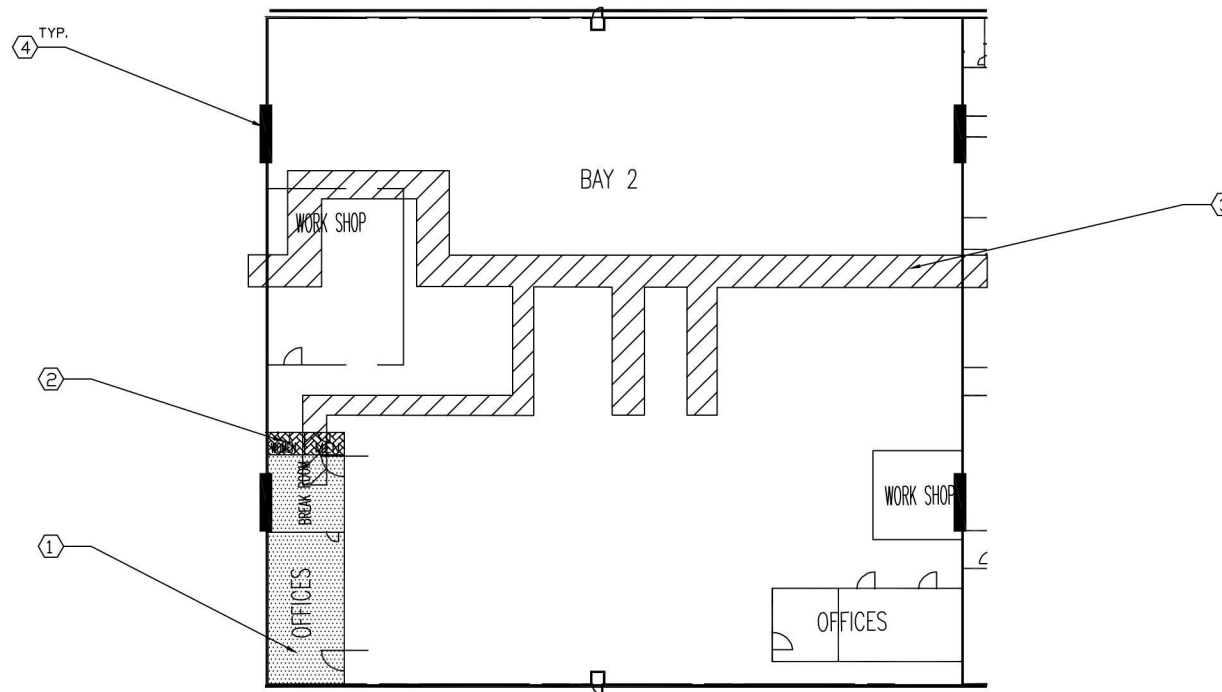
North Section (Bay 2)

- ① 9" GREEN VINYL ASBESTOS TILE AND ASBESTOS CONTAINING MASTIC UNDER CARPET, ON CONCRETE
- ② 9" GREEN VINYL ASBESTOS TILE AND ASBESTOS CONTAINING MASTIC UNDER NON-ACM SHEET VINYL, ON CONCRETE
- ③ ASBESTOS CONTAINING TSI ON PIPING (INCLUDES FITTINGS)
- ④ ASBESTOS CONTAINING CORE FIRE DOORS. INTERNAL FIRE DOORS SEPARATE BAYS AND ARE APPROXIMATELY 10' X 20' EACH.
